**Flood Control Project Maintenance  
Levee Inspections**

**Fall 2018 Levee Maintenance Deficiency Summary Report**

**Flood Control Project Maintenance  
Levee Inspections****LMA District Cover Sheet****Fall 2018 Levee Inspection Results****Reclamation District No. 0501 Ryer Island**

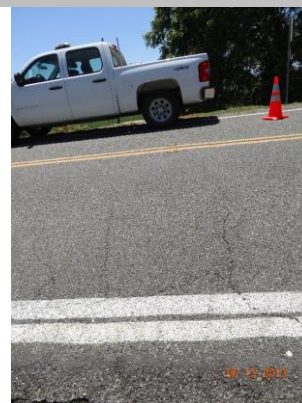
Photo 1 of 3 : UCIP\_FA\_2018\_50025\_59039.jpg

Comment Code					
Inspector Comment					
FS_ID:50025 DS_ID:21063 EP_NO: 11812 Repair Type: Non-Urgent Crossing Status: Found UCIP Comments: 8/22/2016 Crossing has been downgraded from Urgent to Non-Urgent no levee damage appears to be present along pipe alignment. There appears to be an erosion site adjacent to this crossing. Need to coordinate with DWR Inspectors. (DWR UCIP - omagana)6/07/2013 Open cut section of levee on LS slope 8 foot wide--repair work needed. Abandoned pump on waterward berm. Dense vegetation--Recommend removing vegetation along pipe alignment to conduct proper inspection of structure and appurtenances on waterward side. (DWR UCIP - omagana) FIELD_STRUCT_DESC: 14-inch coated steel irrigation discharge pipe and a 1.25-inch electrical conduit of an unknown material through the levee, both 3 feet below the crown. Cutoff wall around the pipe and conduit at the center of the levee. Siphon breaker at the apex of the pipe on the landside (LS) shoulder. Slant pump on the waterside (WS) slope. Discharge structure at the LS toe. Rock revetment on the WS slope. (Plans to replace a 14-inch irrigation pipe through the levee crown and a slant pump on the riverbank authorized under Permit No. 11812, 1976 - Harry H. Rasmussen). [Additional Reference(s): DWR Levee Log, 2005]. FS Date: 8/22/2016

View of levee crown at crossing.

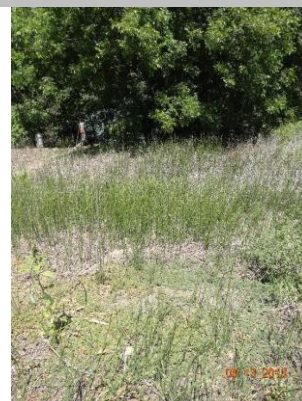
Photo 2 of 3 : UCIP\_FA\_2018\_50025\_59042.jpg

View of WS--pump located at the berm edge.

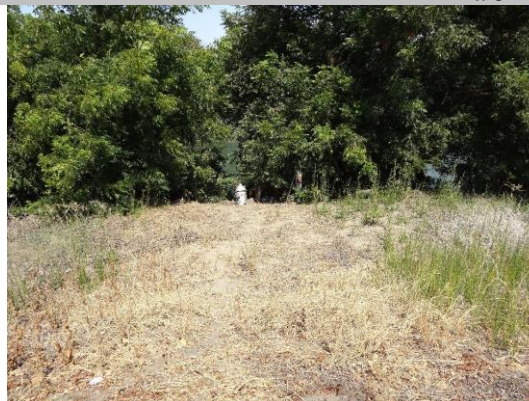
Photo 3 of 3 : UCIP\_FA\_2018\_50025\_75668.jpg

View of WS.

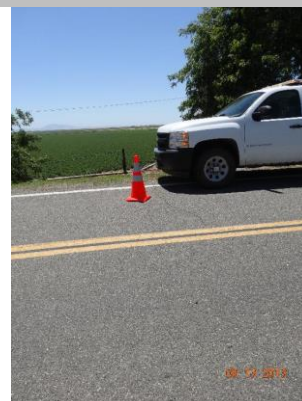
Photo 1 of 3 : UCIP\_FA\_2018\_32546\_59047.jpg

Comment Code						
Inspector Comment						
FS_ID:32546						
DS_ID:21064						
EP_NO: N/A						
Repair Type: Non-Urgent						
Crossing Status: Found						
UCIP Comments: Debris (pipe section) located on waterward berm.						
Dense vegetation limits the inspector's visibility to identify signs of pipe						
failure (leaks) along the waterward slope. Recommend removing						
vegetation along pipe alignment to conduct proper inspection of						
structure and appurtenances.						
FIELD_STRUCT_DESC: 8-inch steel irrigation discharge pipe through						
the levee, 2.7 feet below the crown. Pump in a pump house at the						
landside (LS) toe. [Additional Reference(s): DWR Levee Log, 2005.						
USACE Sacramento O&M Manual 105, April 1959, (HLM 8.2)].						
FS Date: 6/13/2013

View of levee crown at crossing.

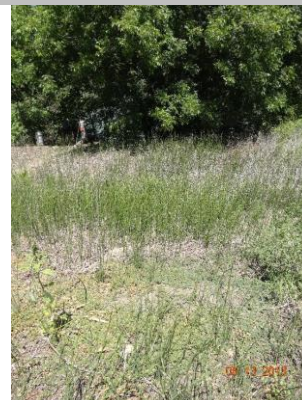
Photo 2 of 3 : UCIP\_FA\_2018\_32546\_59048.jpg

View of waterward side--dense vegetation limits visibility of 8-inch steel pipe. Pump belongs to another crossing.

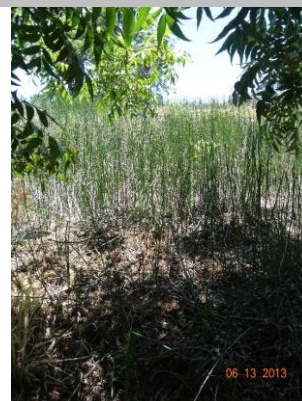
Photo 3 of 3 : UCIP\_FA\_2018\_32546\_59049.jpg

Comment Code						
Inspector Comment						
FS_ID:32546 DS_ID:21064 EP_NO: N/A Repair Type: Non-Urgent Crossing Status: Found UCIP Comments: Debris (pipe section) located on waterward berm. Dense vegetation limits the inspector's visibility to identify signs of pipe failure (leaks) along the waterward slope. Recommend removing vegetation along pipe alignment to conduct proper inspection of structure and appurtenances. FIELD_STRUCT_DESC: 8-inch steel irrigation discharge pipe through the levee, 2.7 feet below the crown. Pump in a pump house at the landside (LS) toe. [Additional Reference(s): DWR Levee Log, 2005. USACE Sacramento O&M Manual 105, April 1959, (HLM 8.2)]. FS Date: 6/13/2013

View of waterward side looking up at levee shoulder.

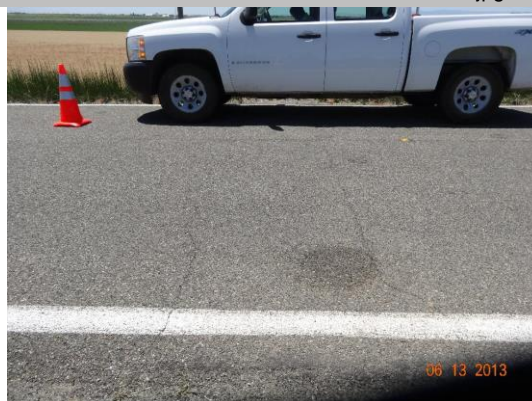
Photo 1 of 3 : UCIP\_FA\_2018\_32547\_59050.jpg

Comment Code					
Inspector Comment					
FS_ID:32547 DS_ID:21080 EP_NO: 18135 Repair Type: Non-Urgent Crossing Status: Found UCIP Comments: Cracks visible on levee crown could be associated with pipe vibration or settlement. Burrow activity on landward side. Recommend removing vegetation along pipe alignment on landward side to conduct proper inspection of structure and appurtenances. FIELD_STRUCT_DESC: 10-inch galvanized iron irrigation discharge pipe through the levee, 3.5 feet below the crown. Cutoff wall around the pipe on the landside (LS) shoulder. Slant pump and pump house on the waterside (WS) slope. Concrete standpipe and power pole at the LS toe. Service pole on the LS slope. Pipe exposed on both slopes. Two crossings are nearby: A 10-inch pipe and an 8-inch pipe crossings are approximately 5 feet apart. (Plans to replace an existing pump and pipeline with a new pump and pipeline authorized under Permit No. 2446, 1957 - Doris R. Geary. Plans to replace an existing water pipe with a 10-inch steel pipe through the levee authorized under Permit No. 18135, 2006 - Charlotte Gilmore). [Additional Reference(s): DWR Levee Log, 2005]. FS Date: 6/7/2013

View of levee crown.

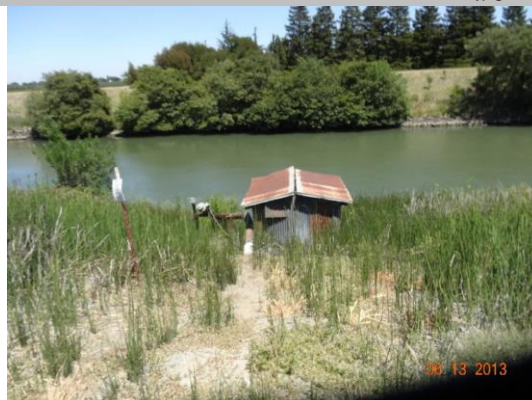
Photo 2 of 3 : UCIP\_FA\_2018\_32547\_59051.jpg

Overview of waterward side--2 crossings located within 5 feet.

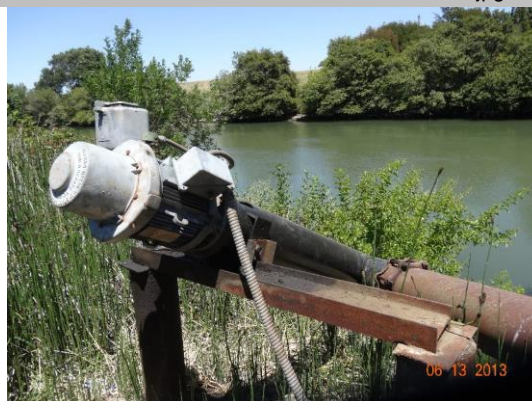
Photo 3 of 3 : UCIP\_FA\_2018\_32547\_59053.jpg

Comment Code						
Inspector Comment						
FS_ID:32547 DS_ID:21080 EP_NO: 18135 Repair Type: Non-Urgent Crossing Status: Found UCIP Comments: Cracks visible on levee crown could be associated with pipe vibration or settlement. Burrow activity on landward side. Recommend removing vegetation along pipe alignment on landward side to conduct proper inspection of structure and appurtenances. FIELD_STRUCT_DESC: 10-inch galvanized iron irrigation discharge pipe through the levee, 3.5 feet below the crown. Cutoff wall around the pipe on the landside (LS) shoulder. Slant pump and pump house on the waterside (WS) slope. Concrete standpipe and power pole at the LS toe. Service pole on the LS slope. Pipe exposed on both slopes. Two crossings are nearby: A 10-inch pipe and an 8-inch pipe crossings are approximately 5 feet apart. (Plans to replace an existing pump and pipeline with a new pump and pipeline authorized under Permit No. 2446, 1957 - Doris R. Geary. Plans to replace an existing water pipe with a 10-inch steel pipe through the levee authorized under Permit No. 18135, 2006 - Charlotte Gilmore). [Additional Reference(s): DWR Levee Log, 2005]. FS Date: 6/7/2013

Slant pump located on waterward side. 10 inch pipe connects at an angle to tar coated pipe.

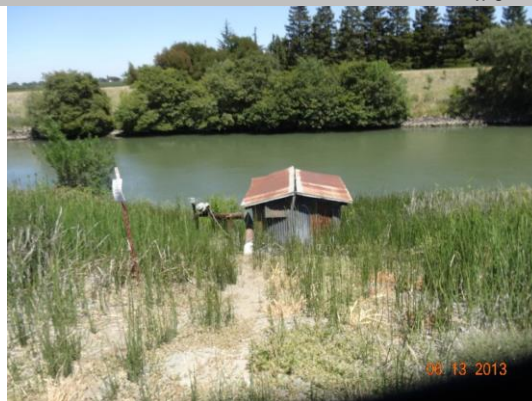
Photo 2 of 3 : UCIP\_FA\_2018\_32548\_59058.jpg

Comment Code						
Inspector Comment						
FS_ID:32548 DS_ID:21079 EP_NO: 2446 Repair Type: Non-Urgent Crossing Status: Found UCIP Comments: Permit documents indicate that pipe does not appear to be properly grouted. Crossing needs to be properly abandoned per CVFPB Title 23--need to find owner. Also recommend removing vegetation along pipe alignment to conduct proper inspection of structure and appurtenances. FIELD_STRUCT_DESC: *ABANDONED* 8-inch steel irrigation discharge pipe through the levee, 6 feet below the crown. Pump on the waterside (WS). Steel plate welded on the WS end. 10-inch steel pipe approximately 5 feet downstream. (Plans to replace an existing pump and pipeline with a new pump and pipeline authorized under Permit No. 2446, 1957 - Doris R. Geary). [Additional Reference(s): DWR Levee Log, 2005. USACE Sacramento O&M Manual 105, April 1959, (HLM 0.6)]. FS Date: 6/13/2013

Overview of waterward side. Two crossings, 10 inch and 8 inch pipelines, less than 5 feet apart.

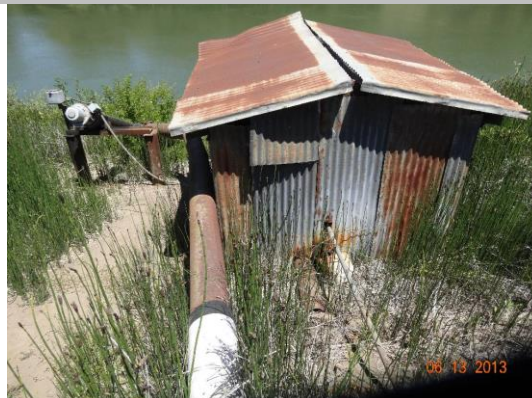
Photo 3 of 3 : UCIP\_FA\_2018\_32548\_59056.jpg

Comment Code						
Inspector Comment						
FS_ID:32548 DS_ID:21079 EP_NO: 2446 Repair Type: Non-Urgent Crossing Status: Found UCIP Comments: Permit documents indicate that pipe does not appear to be properly grouted. Crossing needs to be properly abandoned per CVFPB Title 23--need to find owner. Also recommend removing vegetation along pipe alignment to conduct proper inspection of structure and appurtenances. FIELD_STRUCT_DESC: *ABANDONED* 8-inch steel irrigation discharge pipe through the levee, 6 feet below the crown. Pump on the waterside (WS). Steel plate welded on the WS end. 10-inch steel pipe approximately 5 feet downstream. (Plans to replace an existing pump and pipeline with a new pump and pipeline authorized under Permit No. 2446, 1957 - Doris R. Geary). [Additional Reference(s): DWR Levee Log, 2005. USACE Sacramento O&M Manual 105, April 1959, (HLM 0.6)]. FS Date: 6/13/2013

Pump house is associated with abandoned 8 inch pipe.

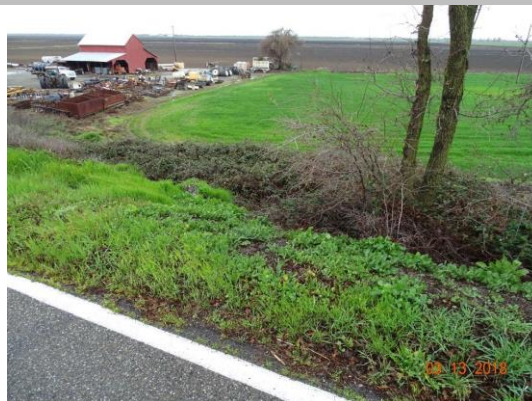
Photo 1 of 1 : FA\_2018\_RD0501\_172\_11\_20180925\_00001.jpg

LM Start	0.84	Rating **	M	Issue No.	11
LM End	0.84	Issue Type +	Ma	Location *	LS
Category	Earthen Levee			GPS Latitude/Longitude	
				Start	End
Item	Vegetation			38.274615 °	38.274615 °
				-121.602718 °	-121.602718 °
DWR ID	DWR_RD0501_04_f_2017_11				
Comment Code					
V2 : Remove the wild growth other than native grasses from the levee slopes.					
Inspector Comment					
Remove thick blackberries at landside toe to allow inspection and access.

Thick blackberries should be removed.

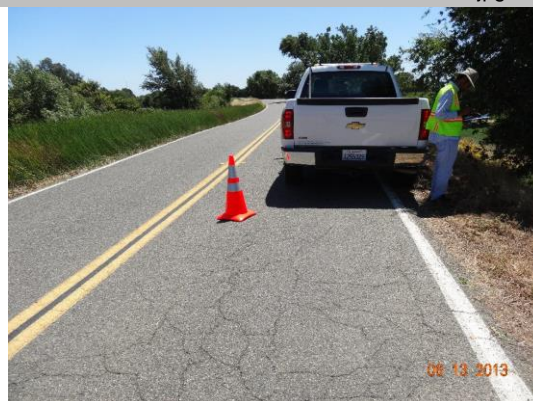
Photo 1 of 3 : UCIP\_FA\_2018\_53356\_59065.jpg

Comment Code					
Inspector Comment					
FS_ID:53356 DS_ID:21072 EP_NO: N/A Repair Type: Urgent Crossing Status: Found UCIP Comments: 07/24/2018 Same as last inspection. LS pipe appears to be rusted through and has too many holes for it to be in operation; therefore keeping Urgent until internal pipe inspection can be performed to determine internal levee integrity is good (D. Sanoski - DWR UCIP).8/22/2016 Assume conditions at this crossing have remained the same--pipe wall is still deteriorating. Unable to locate crossing due to dense vegetation along both WS and LS slopes. Recommend removing vegetation along pipe alignment to conduct proper inspection of structure and appurtenances. (DWR UCIP - omagana)6/13/2013 Pipe has deteriorated--holes present on landward side. Need to contact owner. Unable to determine if crossing is still being used. Dense vegetation limits the inspector's visibility to identify signs of pipe failure (leaks) along the waterward slope. Recommend removing vegetation along pipe alignment to conduct proper inspection of structure and appurtenances. (DWR UCIP - omagana) FIELD_STRUCT_DESC: *ABANDONED* 8-inch steel irrigation discharge pipe through the levee, 2.7 feet below the crown. Pump on the waterside (WS). Steel plate welded on the WS end. Unable to confirm if plate is still present in 2016. [Additional Reference(s): DWR Levee Log, 2005. USACE Sacramento O&M Manual 105, April 1959, (HLM 1.1)]. FS Date: 7/24/2018 11:37:00 AM

View of levee crown at crossing.

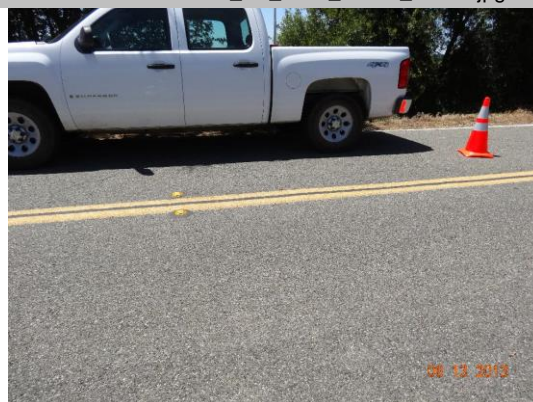
Photo 2 of 3 : UCIP\_FA\_2018\_53356\_59066.jpg

View of levee crown at crossing.

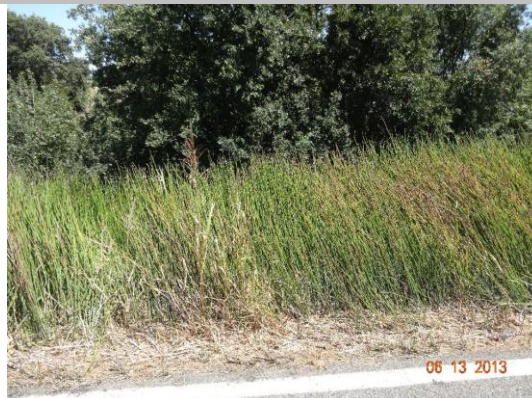
Photo 3 of 3 : UCIP\_FA\_2018\_53356\_59064.jpg

Comment Code						
Inspector Comment						
FS_ID:53356 DS_ID:21072 EP_NO: N/A Repair Type: Urgent Crossing Status: Found UCIP Comments: 07/24/2018 Same as last inspection. LS pipe appears to be rusted through and has too many holes for it to be in operation; therefore keeping Urgent until internal pipe inspection can be performed to determine internal levee integrity is good (D. Sanoski - DWR UCIP).8/22/2016 Assume conditions at this crossing have remained the same--pipe wall is still deteriorating. Unable to locate crossing due to dense vegetation along both WS and LS slopes. Recommend removing vegetation along pipe alignment to conduct proper inspection of structure and appurtenances. (DWR UCIP - omagana)6/13/2013 Pipe has deteriorated--holes present on landward side. Need to contact owner. Unable to determine if crossing is still being used. Dense vegetation limits the inspector's visibility to identify signs of pipe failure (leaks) along the waterward slope. Recommend removing vegetation along pipe alignment to conduct proper inspection of structure and appurtenances. (DWR UCIP - omagana) FIELD_STRUCT_DESC: *ABANDONED* 8-inch steel irrigation discharge pipe through the levee, 2.7 feet below the crown. Pump on the waterside (WS). Steel plate welded on the WS end. Unable to confirm if plate is still present in 2016. [Additional Reference(s): DWR Levee Log, 2005. USACE Sacramento O&M Manual 105, April 1959, (HLM 1.1)]. FS Date: 7/24/2018 11:37:00 AM

High vegetation along waterward side.

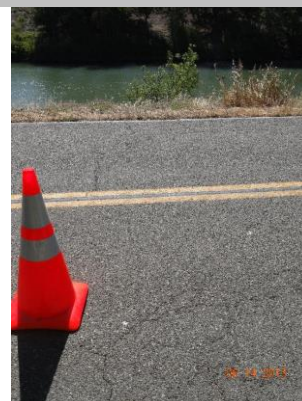
Photo 1 of 3 : UCIP\_FA\_2018\_32550\_59068.jpg

LM Start	1.08	Rating **	M	Issue No.	25	
LM End	1.08	Issue Type +	En	Location *		
Category	Supplemental			GPS Latitude/Longitude		
				Start	End	
Item	DWR UCIP Field Study			38.271400 °	38.271400 °	
				-121.604368 °	-121.604368 °	
DWR ID	21073					
Comment Code						
Inspector Comment						
FS_ID:32550						
DS_ID:21073						
EP_NO: N/A						
Repair Type: Non-Urgent						
Crossing Status: Indicator Found						
UCIP Comments: Unable to determine if the pipe goes through the levee. need As-Built drawings; Need owner information.						
FIELD_STRUCT_DESC: 1.5-inch communications conduit of an unknown material through the levee, 2 feet below the crown. Pole and anchor on the landside (LS) slope. [Additional Reference(s): DWR Levee Log, 2005].						
FS Date: 6/13/2013

Levee crown at crossing.

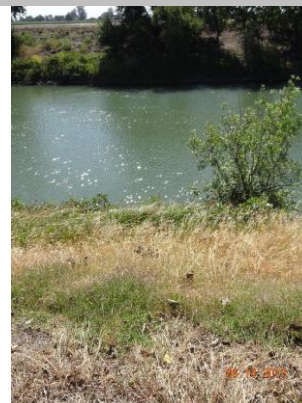
Photo 2 of 3 : UCIP\_FA\_2018\_32550\_59067.jpg

View of waterward side.

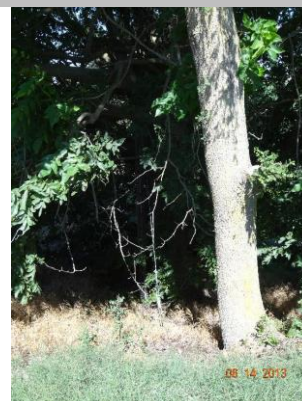
Photo 3 of 3 : UCIP\_FA\_2018\_32550\_59069.jpg

LM Start	1.08	Rating **	M	Issue No.	25 (cont)	
LM End	1.08	Issue Type +	En	Location *		
Category	Supplemental			GPS Latitude/Longitude		
				Start	End	
Item	DWR UCIP Field Study			38.271400 °	38.271400 °	
				-121.604368 °	-121.604368 °	
DWR ID	21073					
Comment Code						
Inspector Comment						
FS_ID:32550 DS_ID:21073 EP_NO: N/A Repair Type: Non-Urgent Crossing Status: Indicator Found UCIP Comments: Unable to determine if the pipe goes through the levee. need As-Built drawings; Need owner information. FIELD_STRUCT_DESC: 1.5-inch communications conduit of an unknown material through the levee, 2 feet below the crown. Pole and anchor on the landside (LS) slope. [Additional Reference(s): DWR Levee Log, 2005]. FS Date: 6/13/2013

View of landward side--power pole and guy wire under trees.

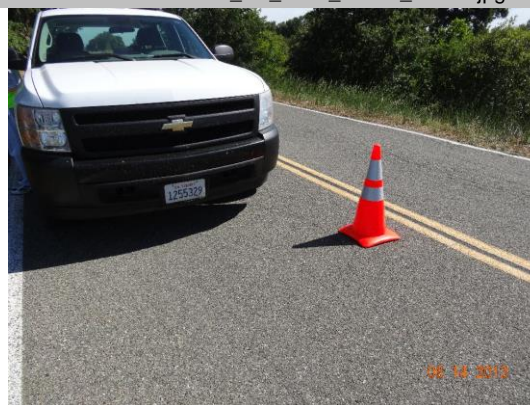
Photo 1 of 3 : UCIP\_FA\_2018\_32551\_59070.jpg

Comment Code					
Inspector Comment					
FS_ID:32551 DS_ID:21074 EP_NO: N/A Repair Type: Non-Urgent Crossing Status: Found UCIP Comments: Unable to determine status of crossing. Pipe visible on waterward side--could be the pipe that was supposed to be removed under permit number 13983 (1985). Also present is a 1.5 inch conduit along the 8 inch pipe. Need to coordinate with owner. FIELD_STRUCT_DESC: 8-inch steel irrigation discharge pipe through the levee, 6.4 feet below the crown. Pump on a pile structure in the stream. Service pole on the landside (LS) slope. (8-inch pipe should have been removed and replaced with a 12-inch pipe authorized under Permit No. 13983, 1984 - Mrs. John Thomas). [Additional Reference(s): DWR Levee Log, 2005. USACE Sacramento O&M Manual 105, April 1959, (HLM 1.3)]. FS Date: 6/13/2013

View of levee crown at crossing.

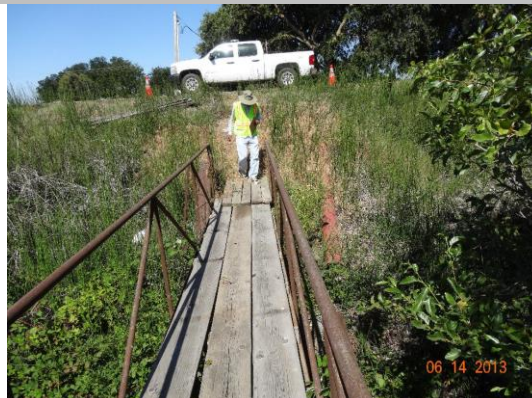
Photo 2 of 3 : UCIP\_FA\_2018\_32551\_59072.jpg

Comment Code						
Inspector Comment						
FS_ID:32551 DS_ID:21074 EP_NO: N/A Repair Type: Non-Urgent Crossing Status: Found UCIP Comments: Unable to determine status of crossing. Pipe visible on waterward side--could be the pipe that was supposed to be removed under permit number 13983 (1985). Also present is a 1.5 inch conduit along the 8 inch pipe. Need to coordinate with owner. FIELD_STRUCT_DESC: 8-inch steel irrigation discharge pipe through the levee, 6.4 feet below the crown. Pump on a pile structure in the stream. Service pole on the landside (LS) slope. (8-inch pipe should have been removed and replaced with a 12-inch pipe authorized under Permit No. 13983, 1984 - Mrs. John Thomas). [Additional Reference(s): DWR Levee Log, 2005. USACE Sacramento O&M Manual 105, April 1959, (HLM 1.3)]. FS Date: 6/13/2013

Abandoned pipe to the right of walkway.

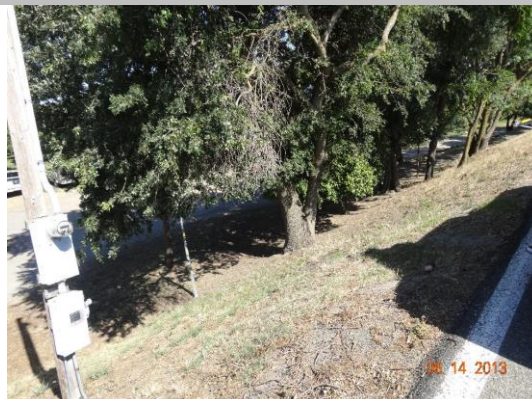
Photo 3 of 3 : UCIP\_FA\_2018\_32551\_59071.jpg

View of landward side--power pole on slope.

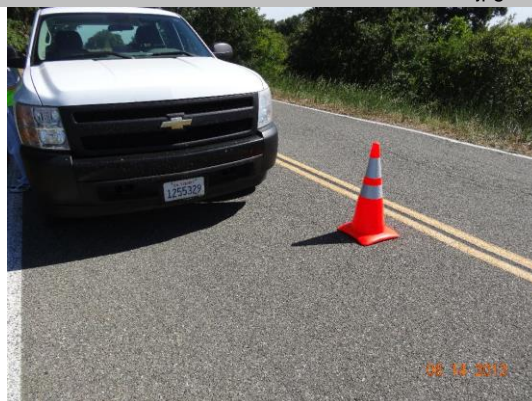
Photo 1 of 3 : UCIP\_FA\_2018\_32552\_59073.jpg

FS\_ID:32552  
DS\_ID:21095  
EP\_NO: 13983  
Repair Type: Non-Urgent  
Crossing Status: Found  
UCIP Comments: Abandoned pipe was to be removed during the installation of new 12-inch pipe crossing. Need to contact pipe owner. Unable to confirm crossing--need additional records for crossing.  
FIELD\_STRUCT\_DESC: 12-inch coated steel irrigation discharge pipe through the levee, 5 feet below the crown. Cutoff wall around the pipe at the center of the levee. Siphon breaker at the apex of the pipe on the landside (LS) shoulder. Pump on a pile structure in the stream. Service pole on the LS slope. Pipe connects to a 10-inch steel pipe along the LS slope at the shoulder and similarly to a preexisting 8-inch pipe on the waterside (WS). (8-inch pipe should have been removed and replaced with a 12-inch pipe authorized under Permit No. 13983, 1984 - Mrs. John Thomas).  
FS Date: 6/13/2013

View of levee crown at crossing.

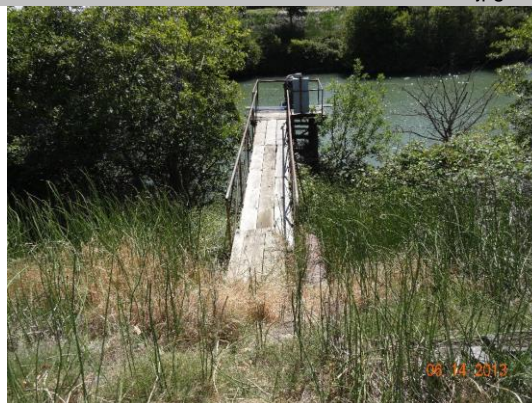
Photo 2 of 3 : UCIP\_FA\_2018\_32552\_59076.jpg

View of waterward side--walkway, pump, conduit, and pipe.

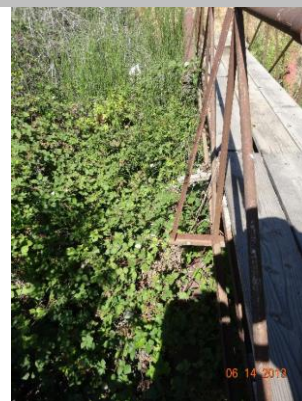
Photo 3 of 3 : UCIP\_FA\_2018\_32552\_59075.jpg

Comment Code						
Inspector Comment						
FS_ID:32552 DS_ID:21095 EP_NO: 13983 Repair Type: Non-Urgent Crossing Status: Found UCIP Comments: Abandoned pipe was to be removed during the installation of new 12-inch pipe crossing. Need to contact pipe owner. Unable to confirm crossing--need additional records for crossing. FIELD_STRUCT_DESC: 12-inch coated steel irrigation discharge pipe through the levee, 5 feet below the crown. Cutoff wall around the pipe at the center of the levee. Siphon breaker at the apex of the pipe on the landside (LS) shoulder. Pump on a pile structure in the stream. Service pole on the LS slope. Pipe connects to a 10-inch steel pipe along the LS slope at the shoulder and similarly to a preexisting 8-inch pipe on the waterside (WS). (8-inch pipe should have been removed and replaced with a 12-inch pipe authorized under Permit No. 13983, 1984 - Mrs. John Thomas). FS Date: 6/13/2013

Pipe suspended on waterward side along walkway.

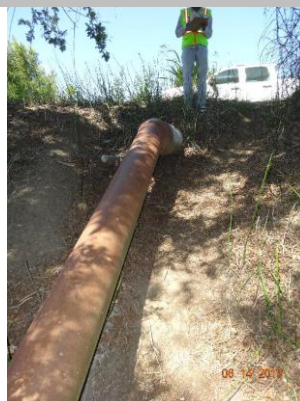
Photo 1 of 3 : UCIP\_FA\_2018\_44471\_33491.jpg

Comment Code						
Inspector Comment						
FS_ID:44471 DS_ID:21076 EP_NO: 16906 Repair Type: Non-Urgent Crossing Status: Found UCIP Comments: Crossing was running during site inspection. Dense vegetation limits the inspector's visibility to identify signs of pipe failure (leaks) along the landward slope. Recommend removing vegetation along pipe alignment to conduct proper inspection of structure and appurtenances. FIELD_STRUCT_DESC: 14-inch coated steel irrigation discharge pipe through the levee, 2.2 feet below the crown. Pump on a pile structure in the stream. Concrete standpipe on the landside (LS). Pipe exposed on the LS slope. Two conduits present: 3-inch conduit is disconnected, and 1.5-inch electrical conduit appears to be active. (Plans to replace an existing 10-inch pipe with a 14-inch irrigation pipe through the levee authorized under Permit No. 16906, 1998 - Neil R. Hamilton/DCC Engineering Company). [Additional Reference(s): DWR Levee Log, 2005]. FS Date: 6/13/2013

Waterward side-pipe along slope.

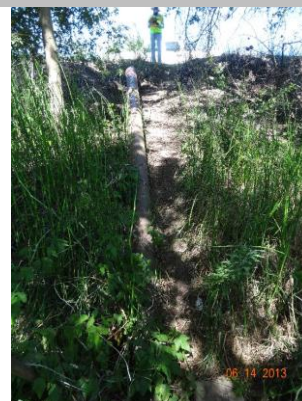
Photo 3 of 3 : UCIP\_FA\_2018\_44471\_33496.jpg

Comment Code						
Inspector Comment						
FS_ID:44471 DS_ID:21076 EP_NO: 16906 Repair Type: Non-Urgent Crossing Status: Found UCIP Comments: Crossing was running during site inspeciton. Dense vegetation limits the inspector's visibility to identify signs of pipe failure (leaks) along the landward slope. Recommend removing vegetation along pipe alignment to conduct proper inspection of structure and appurtenances. FIELD_STRUCT_DESC: 14-inch coated steel irrigation discharge pipe through the levee, 2.2 feet below the crown. Pump on a pile structure in the stream. Concrete standpipe on the landside (LS). Pipe exposed on the LS slope. Two conduits present: 3-inch conduit is disconnected, and 1.5-inch electrical conduit appears to be active. (Plans to replace an existing 10-inch pipe with a 14-inch irrigation pipe through the levee authorized under Permit No. 16906, 1998 - Neil R. Hamilton/DCC Engineering Company). [Additional Reference(s): DWR Levee Log, 2005]. FS Date: 6/13/2013

Overview of waterward side.

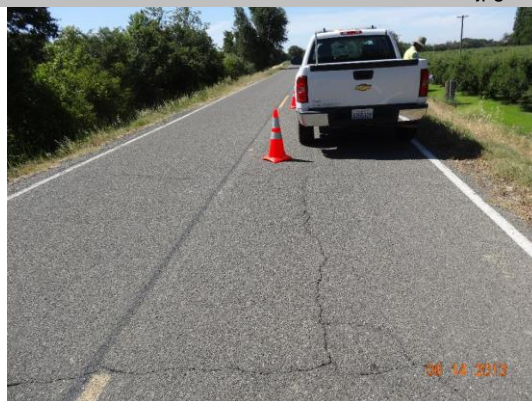
Photo 1 of 3 : UCIP\_FA\_2018\_32553\_59082.jpg

Comment Code						
Inspector Comment						
FS_ID:32553						
DS_ID:21077						
EP_NO: N/A						
Repair Type: Non-Urgent						
Crossing Status: Found						
UCIP Comments: Dense vegetation limits the inspector's visibility to identify signs of pipe failure (leaks) along the waterward and landward slope. Recommend removing vegetation along pipe alignment to conduct proper inspection of structure and appurtenances.						
FIELD_STRUCT_DESC: 14-inch steel irrigation discharge pipe through the levee, 8 feet below the crown. 2-inch electrical conduit of an unknown material through the levee, at an unknown depth. Siphon breaker on the landside (LS) slope. Pump on a pile structure in the stream. [Additional Reference(s): DWR Levee Log, 2005. USACE Sacramento O&M Manual 105, April 1959, (HLM 2.0)].						
FS Date: 6/13/2013

View of levee crown at crossing.

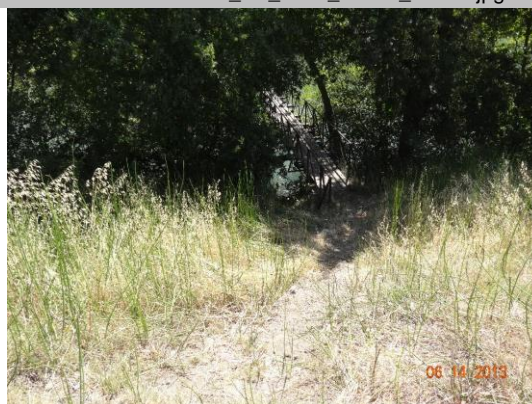
Photo 2 of 3 : UCIP\_FA\_2018\_32553\_59081.jpg

View of waterward side.

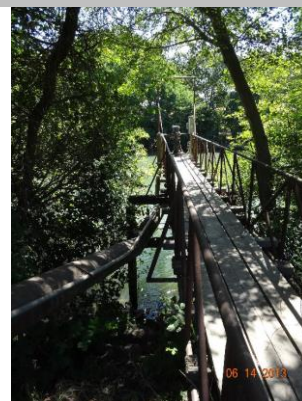
Photo 3 of 3 : UCIP\_FA\_2018\_32553\_59080.jpg

Item	DWR UCIP Field Study			38.260407°	38.260407°
				-121.601365°	-121.601365°
DWR ID	21077				
Comment Code					
Inspector Comment					
FS_ID:32553 DS_ID:21077 EP_NO: N/A Repair Type: Non-Urgent Crossing Status: Found UCIP Comments: Dense vegetation limits the inspector's visibility to identify signs of pipe failure (leaks) along the waterward and landward slope. Recommend removing vegetation along pipe alignment to conduct proper inspection of structure and appurtenances. FIELD_STRUCT_DESC: 14-inch steel irrigation discharge pipe through the levee, 8 feet below the crown. 2-inch electrical conduit of an unknown material through the levee, at an unknown depth. Siphon breaker on the landside (LS) slope. Pump on a pile structure in the stream. [Additional Reference(s): DWR Levee Log, 2005. USACE Sacramento O&M Manual 105, April 1959, (HLM 2.0)]. FS Date: 6/13/2013

Waterward side--catwalk, conduit line, pump, and support piles.

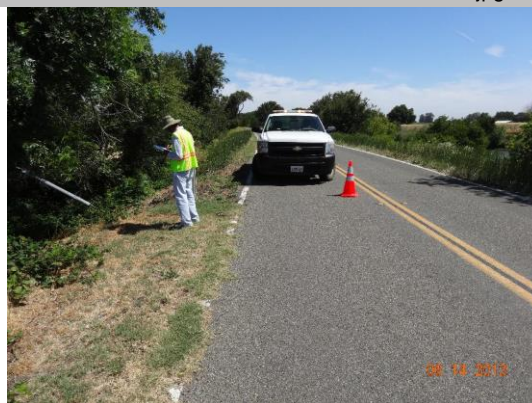
Photo 1 of 3 : UCIP\_FA\_2018\_32863\_59483.jpg

Comment Code						
Inspector Comment						
FS_ID:32863 DS_ID:21078 EP_NO: N/A Repair Type: Non-Urgent Crossing Status: Found UCIP Comments: Broken concrete box on landward slope. Disturbed soil on waterward slope--unable to determine section disturbed. Dense vegetation limits the inspector's visibility to identify signs of pipe failure (leaks) along the waterwar slope. Recommend removing vegetation along pipe alignment to conduct proper inspection of structure and appurtenances. FIELD_STRUCT_DESC: *ABANDONED* 6-inch and working 6-inch steel irrigation discharge pipes through the levee, 2.5 feet and 5 feet below the crown, respectively. Pipes are within 5 feet of each other. 1.5-inch electrical conduit of an unknown material through the levee, at an unknown depth. Pump in a pump house on the waterside (WS) slope. [Additional Reference(s): DWR Levee Log, 2005. USACE Sacramento O&M Manual 105, April 1959, (HLM 2.3)]. FS Date: 6/13/2013

View of levee crown at crossing.

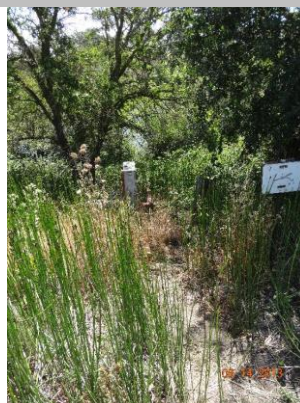
Photo 2 of 3 : UCIP\_FA\_2018\_32863\_59484.jpg

Comment Code						
Inspector Comment						
FS_ID:32863 DS_ID:21078 EP_NO: N/A Repair Type: Non-Urgent Crossing Status: Found UCIP Comments: Broken concrete box on landward slope. Disturbed soil on waterward slope--unable to determine section disturbed. Dense vegetation limits the inspector's visibility to identify signs of pipe failure (leaks) along the waterwar slope. Recommend removing vegetation along pipe alignment to conduct proper inspection of structure and appurtenances. FIELD_STRUCT_DESC: *ABANDONED* 6-inch and working 6-inch steel irrigation discharge pipes through the levee, 2.5 feet and 5 feet below the crown, respectively. Pipes are within 5 feet of each other. 1.5-inch electrical conduit of an unknown material through the levee, at an unknown depth. Pump in a pump house on the waterside (WS) slope. [Additional Reference(s): DWR Levee Log, 2005. USACE Sacramento O&M Manual 105, April 1959, (HLM 2.3)]. FS Date: 6/13/2013

View of waterward side with dense vegetation along slope.

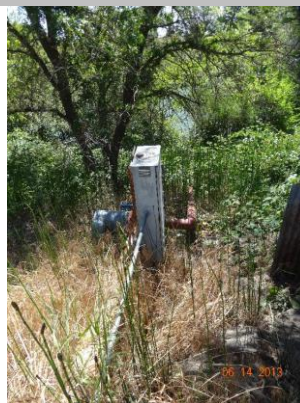
Photo 3 of 3 : UCIP\_FA\_2018\_32863\_59480.jpg

View of waterward side--conduit, pump, control panel, and pipe. Soil piled on right corner of photo--excavation?

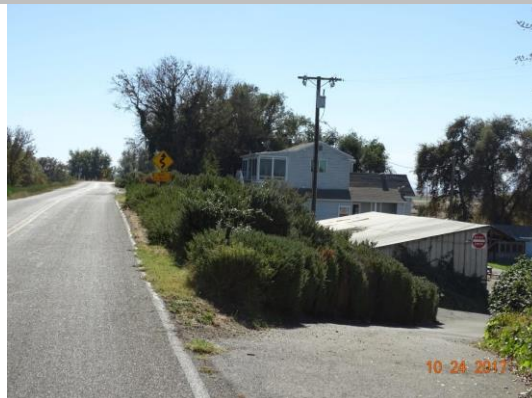
Photo 1 of 1 : FA\_2018\_RD0501\_172\_17\_20180925\_00003.jpg

LM Start	2.17	Rating **	M	Issue No.	17
LM End	2.28	Issue Type +	En	Location *	LS
Category	Earthen Levee			GPS Latitude/Longitude	
				Start	End
Item	Vegetation			38.255987°	38.254465°
				-121.600993°	-121.601450°
DWR ID	DWR_RD0501_04_s_2017_17				
Comment Code					
V6 : Landscaping					
Inspector Comment					
Landside landscaping should be thinned and managed to allow inspection and access to levee slope and to and 10' easement.

Landside landscaping should be thinned and managed to allow inspection and access to levee slope and to and 10' easement.
